ONE WORLD TRADE CENTER FIRE

New York, N.Y.
February 13, 1975

HIGH-RISE FIRE SAFETY

**INVESTIGATION AND REPORT BY
W. ROBERT POWERS, *Superintendent***

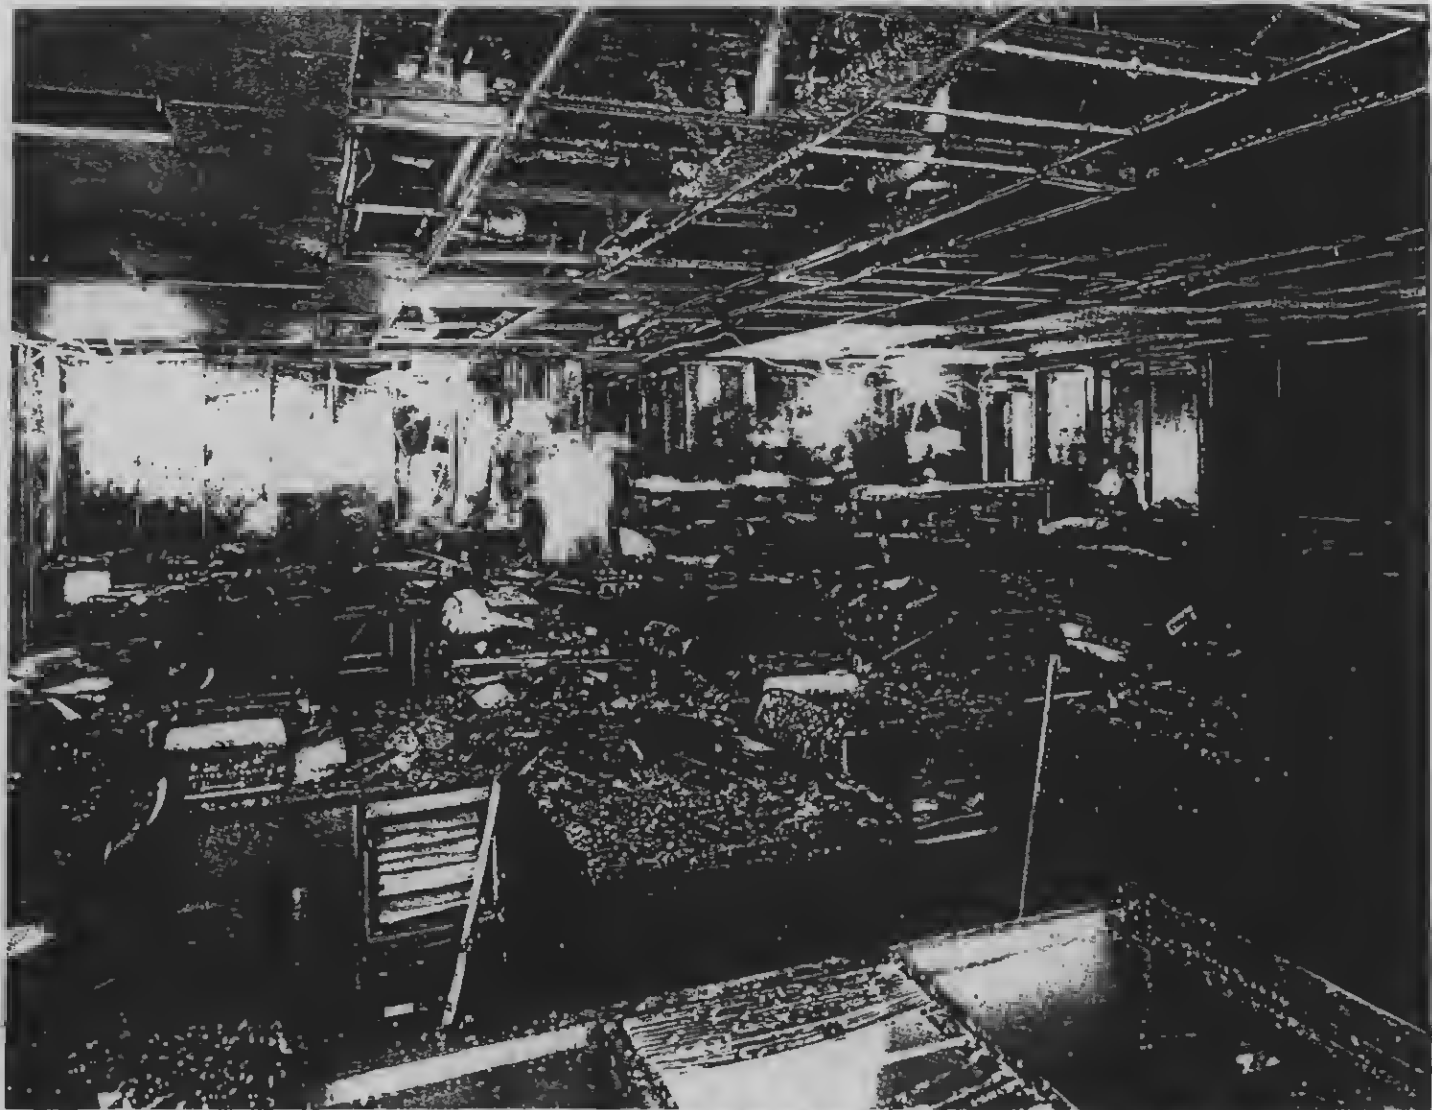
R. J. Saunders office on 11th floor file room is at left and office of fire origin is behind partition at right of picture.
